NAVAER 00-75-510

THE NAVAL AVIATION SAFETY REVIEW

VOLUME 5

NUMBER 3

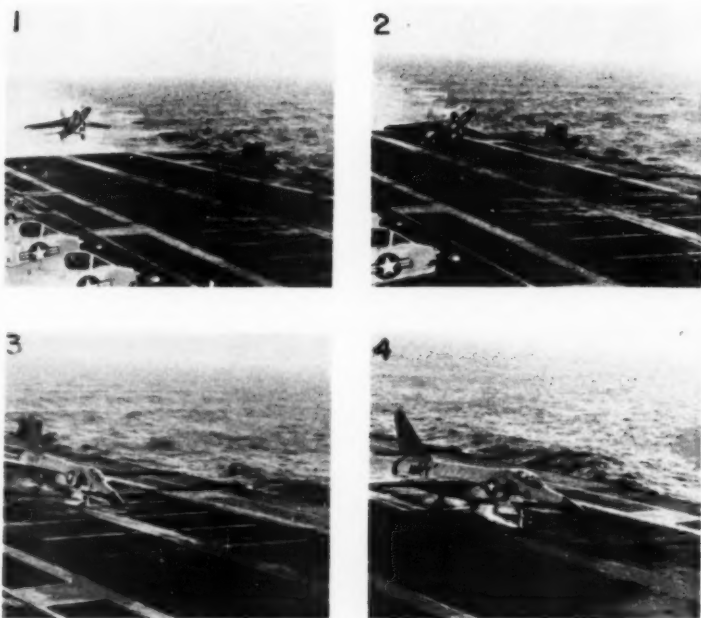
An LSO waveoff, full power and rotation brought about picture number 1. In number 2 the wire is caught with the jet beginning to climb. Pictures 3 and 4 show return to the deck and runout.

wheels and caused substantial damage to the nose wheel well.

Several comments from the chain of command concerning initial carrier qualification landings are worthy of note: "This accident," said one "... points out the necessity of impressing young pilots with the importance of flying a constant speed, constant rate of descent mirror approach regardless of the deck conditions. It is far better to take a bolter than try to outguess or follow the movements of a pitching deck." Another said, "Experience to date has also indicated that accepting bolters during this stage has had no detrimental effect upon the quality of the end product, since in every case the fleet replacement pilots have satisfactorily completed their carrier qualifications without excessive bolters during the latter periods."

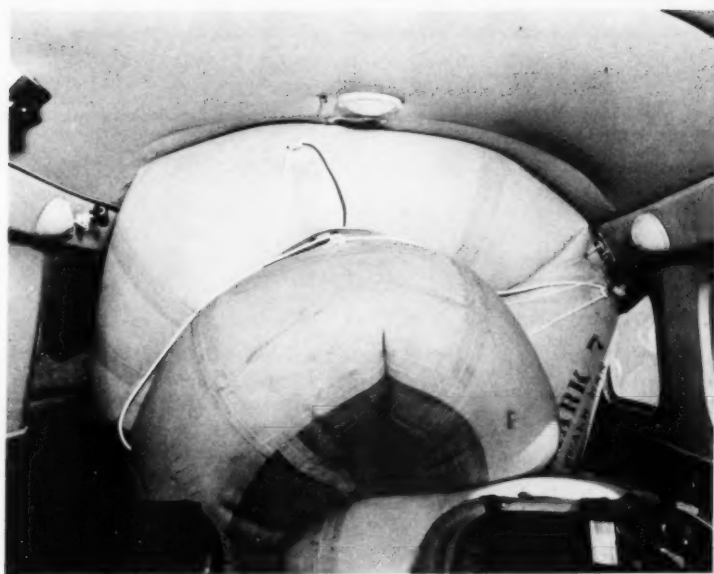
THE photo here appeared in the June issue of *APPROACH*, with an invitation to readers to submit their idea for a suitable caption. We also asked for ideas on how to handle this embarrassing and dangerous situation.

Most of the suggestions dealt with cutting the raft open to deflate it, and only a few of them mentioned the serious hazard of introducing a large quantity of CO₂ into the cockpit of the *Beech*. "A few lusty stabs with the pilot's trusty (rusty) survival knife should do the trick," says one reader, but by all means insure that a maximum of fresh air is coming in. If oxygen is aboard (did you check before takeoff?) it should be used on 100%. One reader suggested singeing a small area of the raft with a cigaret lighter to make it hard and brittle, then poking a small hole in the singed area with a pencil, so the CO₂ could bleed off slowly.

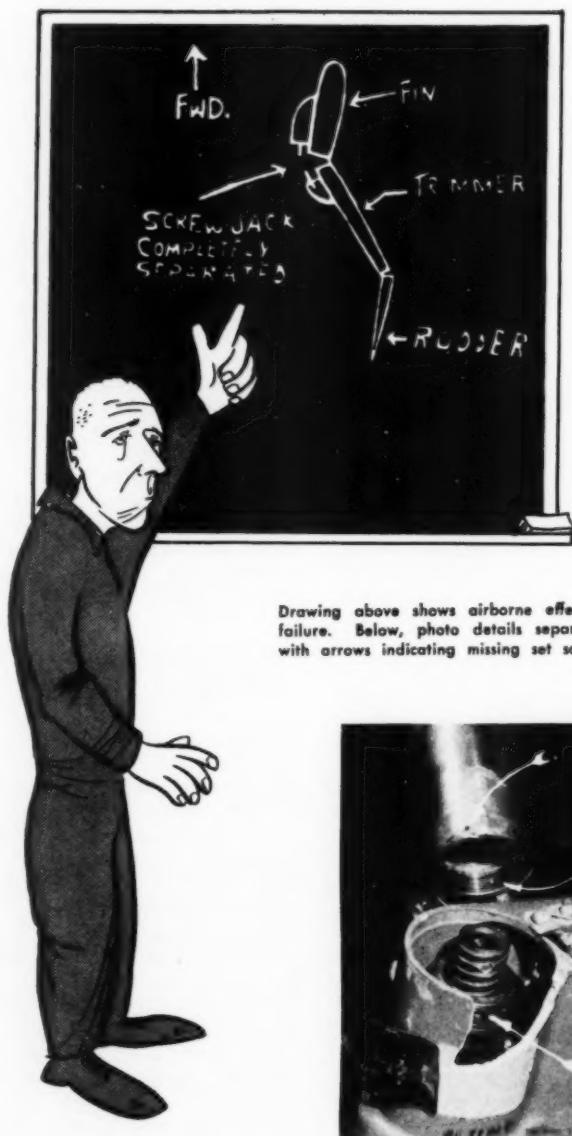
rotor pitch control cables had been reversed, giving the pilot left rudder for right and vice versa. Murphy's Law had been applied and the three mice had failed to catch the error.

Drawing above shows airborne effect of failure. Below, photo details separation with arrows indicating missing set screws.

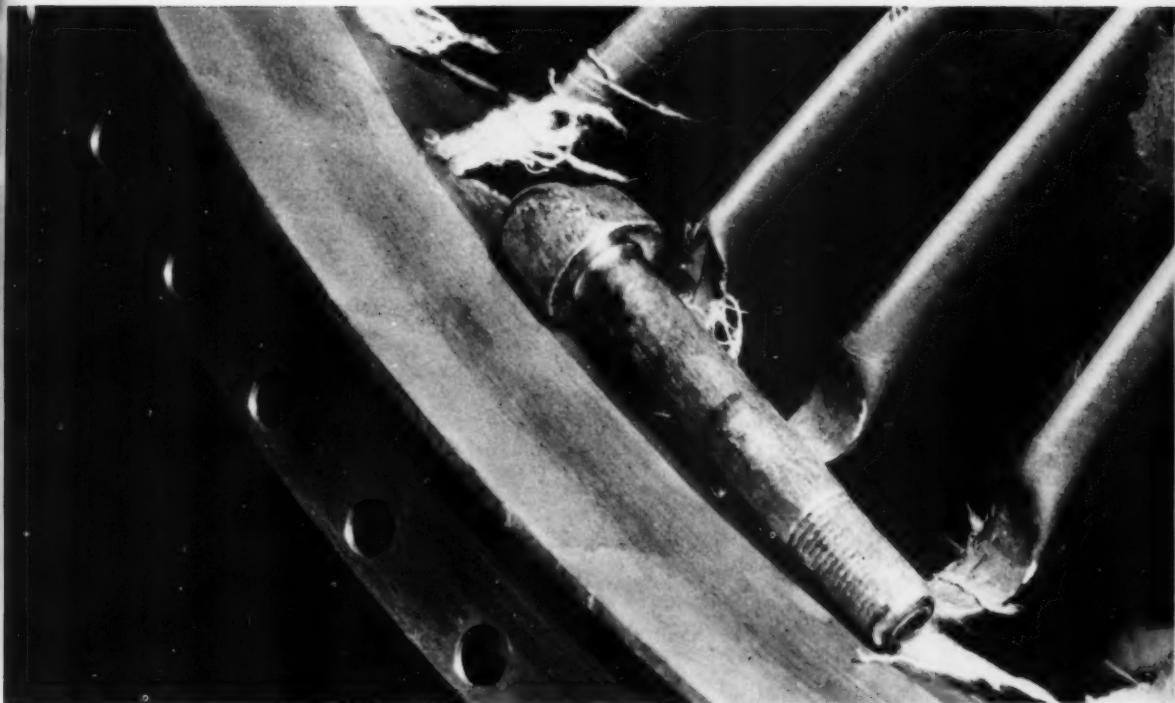
FOREIGN OBJECT DAMAGE—Fragments of cotton rag and internal wrenching bolt lodged on leading edges of J57P4A fourth stage vane and shroud assembly, above, found during disassembly caused extreme damage to 1st, 2nd and 3rd stage compressor assemblies, left. Source of bolt and rag entry is unknown. Recommendations — insure that aircraft ducts are free of loose material prior to engine run-up.

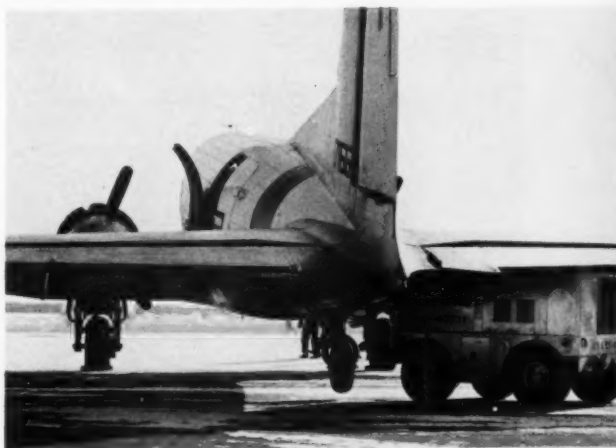
The NC-7 which had been used to start the aircraft was parked slightly to the right and forward of the starboard engine nacelle. The starboard prop struck the NC-7 then the starboard wing passed over the NC-7, tearing a section of the starboard flap. The NC-7 then came in contact with the starboard side of the fuselage causing minor skin damage. The starboard side of the horizontal stabilizer then struck the NC-7 with the tail wheel approximately 81 inches off the deck. Personnel ran out to the aircraft from the line shack and gave an emergency stop to the plane captain.

The aircraft sustained Charlie damage. To effect repairs the following was necessary: Change starboard prop, change starboard engine, change starboard flap, change horizontal stabilizer, and repair minor skin damage to starboard side of fuselage. Cost \$38,520; man-hours 198.

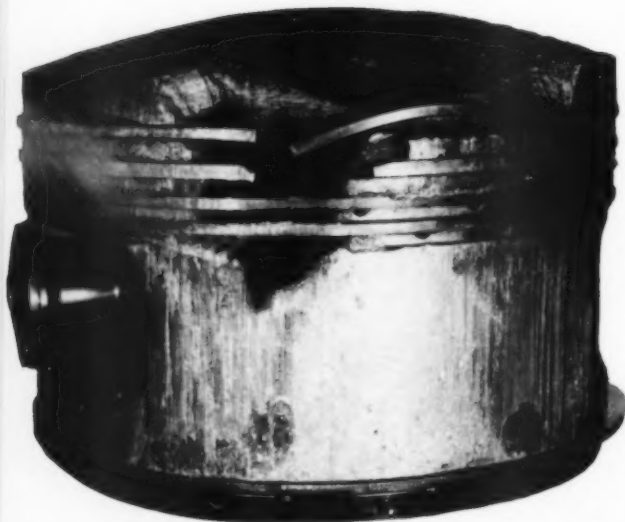
DETONATION—About 5 minutes after a go-around on a radar controlled approach, the AD-7's engine back-fired and began to run rough. Ground witnesses later reported a large puff of white smoke. The pilot made a forced landing at a nearby civil airport. Subsequent engine inspection revealed severe detonation damage (photo above). The landing was successful and no further damage occurred.
